Water safety in the water distribution networks of small towns

The case of Bushenyi-Ishaka municipality, Uganda

MSc Thesis **UWS-WSE.19-30**

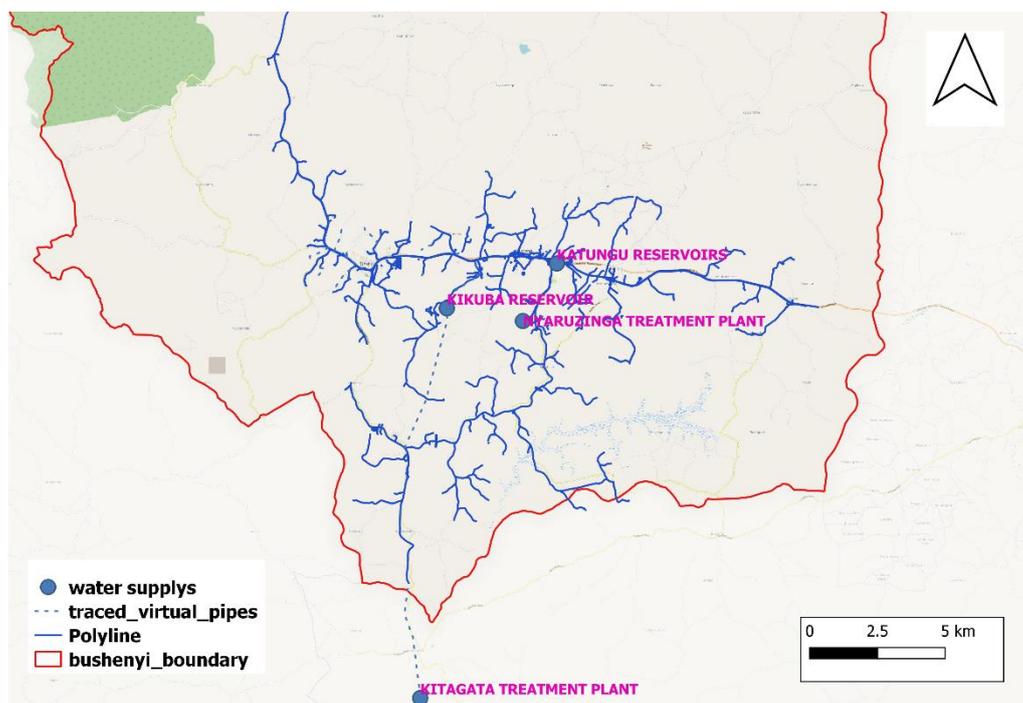
Figure 3 Map of the water distribution network in Bushenyi-Ishaka municipality

The water distribution network for Bushenyi-Ishaka Municipality is approximately 400-500 km long. However, this study was focused on the Ishaka area which has about 100 km length of pipes. The pipes consist of various materials as shown in Figure 5, including asbestos cement (AC), polyethylene (PE), galvanized iron (GI), ductile iron (DI), steel (ST) and polyvinyl chloride (PVC) while the pipe diameters range between 0.75 – 10 (inches) (Nyakana, 2018, Twesigye, 2018).

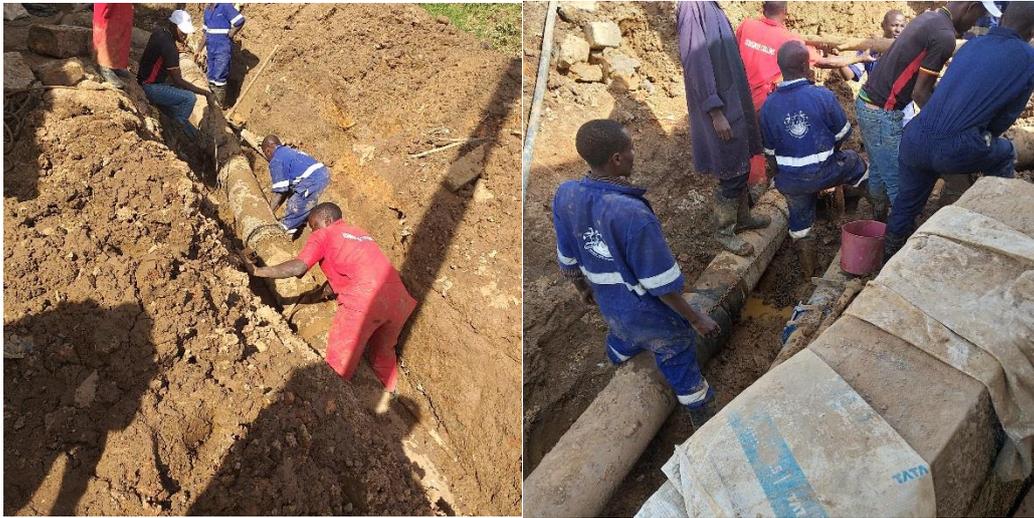
Figure 4 pipe laying during repair of a burst on the transmission mains in Kitagata

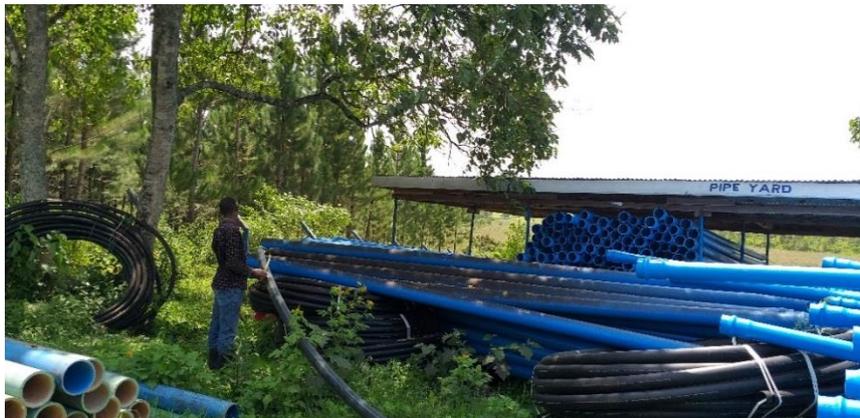
Figure 5 different types of pipes used in the WDN of Bushenyi water supply system

Apart from the risks based on the sanitary risks checklist, there were many others observed. Along the mains, there was a lot of solid waste dumping, and some exposed pipes were found near a trench for grey water. The secondary main supplying Kikuba village passes through the solid waste dumping site. During the rainy season, the water is at risk of microbial contamination. Some exposed pipes were found in stormwater and greywater drainages which are dirty and soaked in solid waste (as seen in Figure 26, Figure 24). These pipes are at risk of physical breakage, and the contaminants can easily intrude through the joints in times of low pressure in the pipe network. During the transect walks, uncapped pipes were seen left unused near the trenches. Leaving pipes uncapped at the ends makes them vulnerable to foreign matter getting into the pipe. The pipes stored in the pipe yard are also left uncapped as seen in Figure 5.

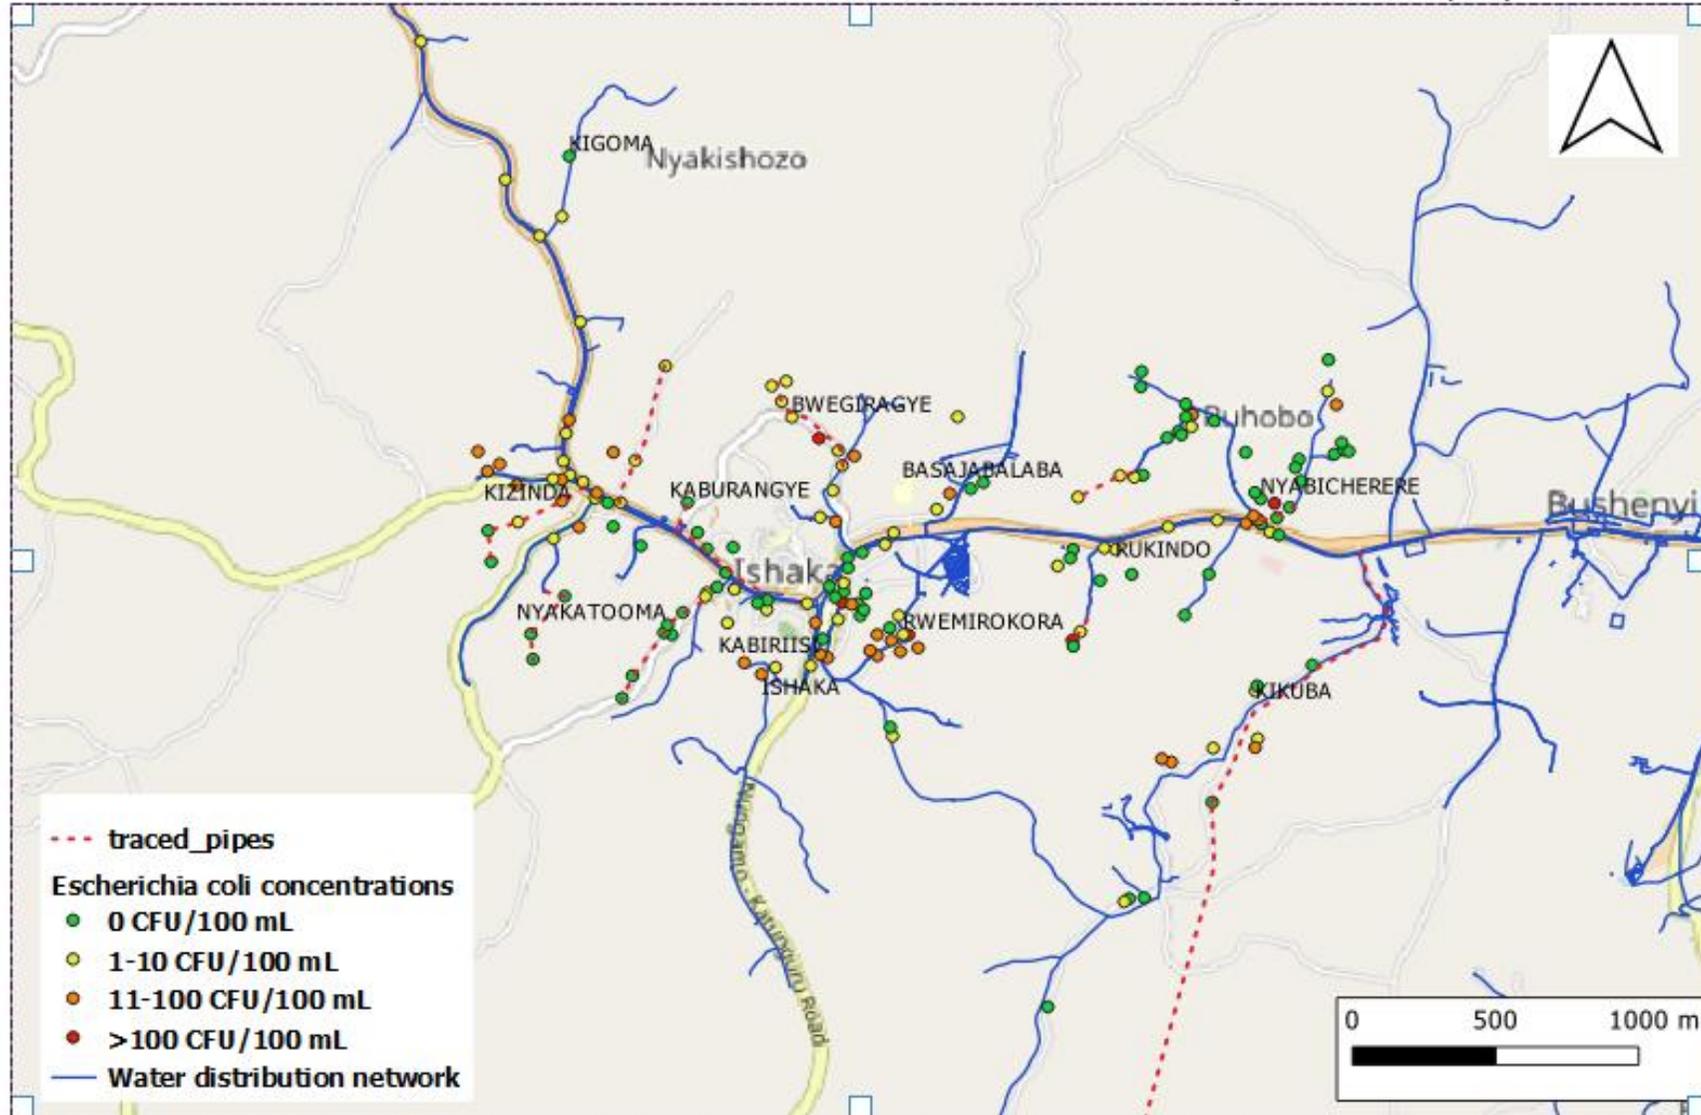
It can also be seen that, in some villages like Bassajabalaba and Nyakatooma, the samples from the same pipeline some were not contaminated while others were highly contaminated. In other cases like Bwegiragye and Kizinda, all samples from the same secondary main were contaminated. It is also evident that most samples from urban centres such as Ishaka, Kizinda and St. Kaggwa market centre in Nyabicherere were contaminated.

Figure 9 map of *E. coli* concentrations in the samples collected

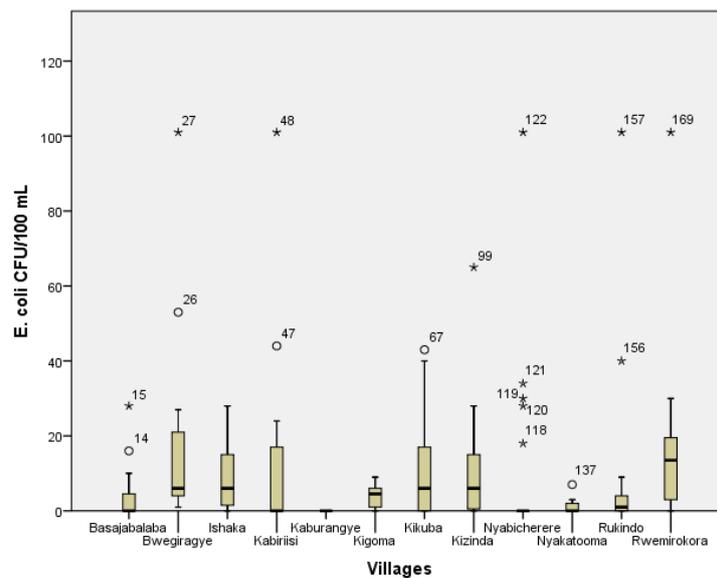
For better visualization of the distribution, the extreme outliers (<100CFU/100 mL) were presented as 101 CFU/100 mL. According to the box plot shown in Figure 10 the *E. coli* concentrations in the upper quartiles shows high variability compared to the lower quartiles in all villages. The upper whiskers are more prolonged than lower whiskers which depict that data is positively skewed. Kaburangye and Nyabicherere villages have a similar distribution of *E. coli* concentrations. The lowest median is 0 CFU/100 mL in Bassajabalaba, Kabiriisi, Kaburangye, Nyabicherere, and Nyakatooma villages but these villages have a different distribution of *E. coli* concentration. Rwemirokora has the highest median of 13.5 CFU/100 mL among the villages.

Figure 10 box plots showing *E. coli* concentrations at the village scale

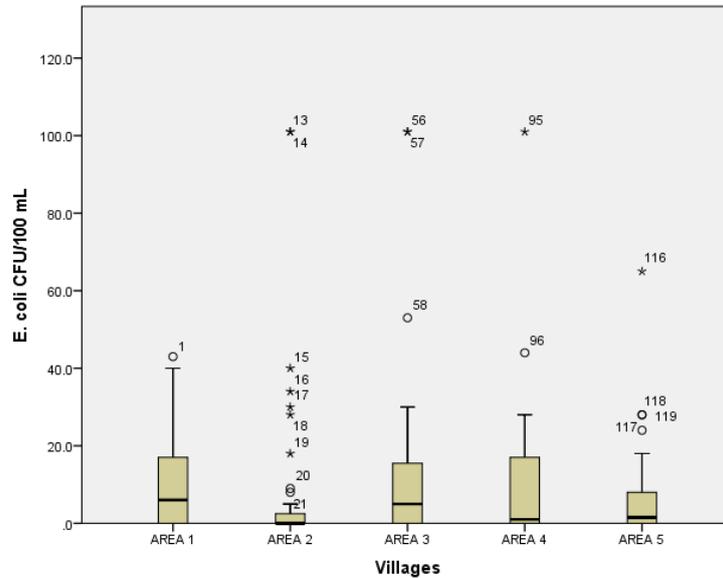
For better visualization of the distribution, the extreme outliers (<100CFU/100 mL) were presented as 101 CFU/100 mL. According to the box plot shown in Figure 11, the general distribution of the *E. coli* concentrations is similar in the lower quartile and varies significantly in the uppermost quartile. AREA 3 has the highest median while AREA 2 has the lowest median. AREA 4 and AREA 5 have equal median values but with a different distribution. AREA 2 has the highest number of outliers.

Figure 11 box pots showing *E. coli* concentrations at a medium scale

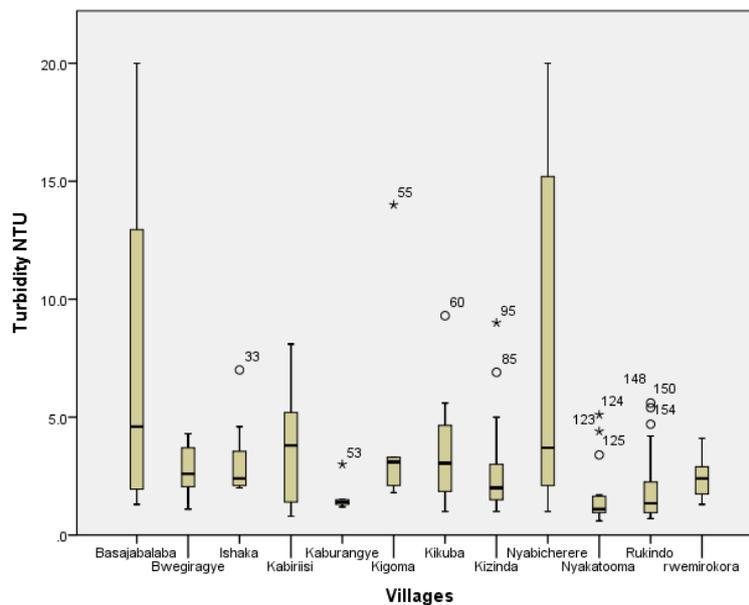
For better visualization, the turbidity values >20 NTU are excluded from the boxplot. However, the box plot in Figure 12 shows Nyabicherere and Bassajabalaba had the most varying turbidity levels while Kaburangye had the least variation. The highest median value is in Bassajabalaba while the lowest is in Kaburangye. It is notable that the median turbidity levels in all villages are < 5 NTU.

Figure 12 box plots showing turbidity levels at the village scale

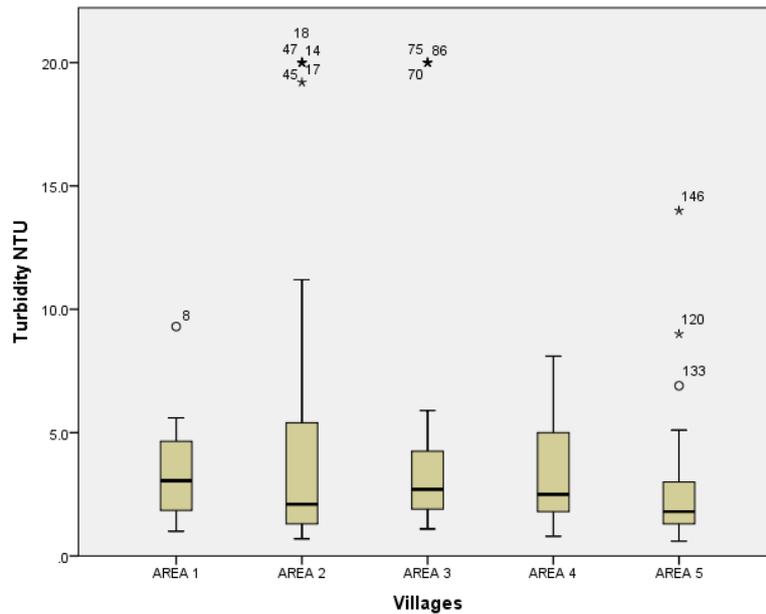
Figure 13 depicts that, all the areas at medium scale have median value < 5 NTU. AREA 2 and AREA 5 have many outliers. AREA 3 has a low variation in data distribution and also has the highest mean value. It is noticeable that area 2 which is a combination of Nyabicherere and Rukindo, has the highest variation in data.

Figure 13 box plots showing turbidity levels at medium scale

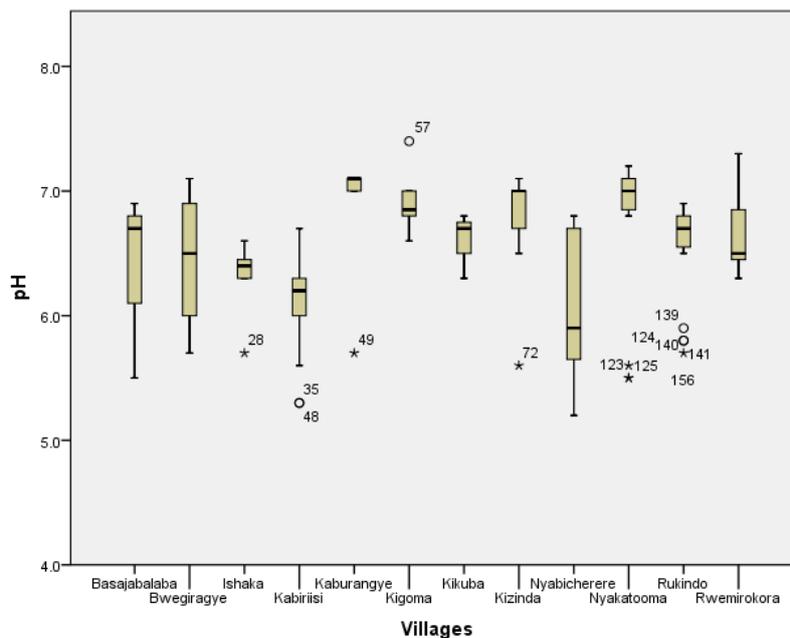
pH was used to measure the acidity or the alkalinity of the water. According to the graph in Figure 14, the pH values ranged between 5.2 and 7.4. Out of 169 samples, 135 samples (80%) had a pH value lower than 7, 18 samples (10.6%) had a neutral pH value while 16 samples (9.4%) had a pH value above 7. It is important to note that most outliers have a pH value below 6. The pH values of Bassajabalaba, Bwegiragye, and Nyabicherere vary significantly compared to those of other villages. Kaburangye has pH values with a median of about 7.

Figure 14 a box plot of pH values at village scale

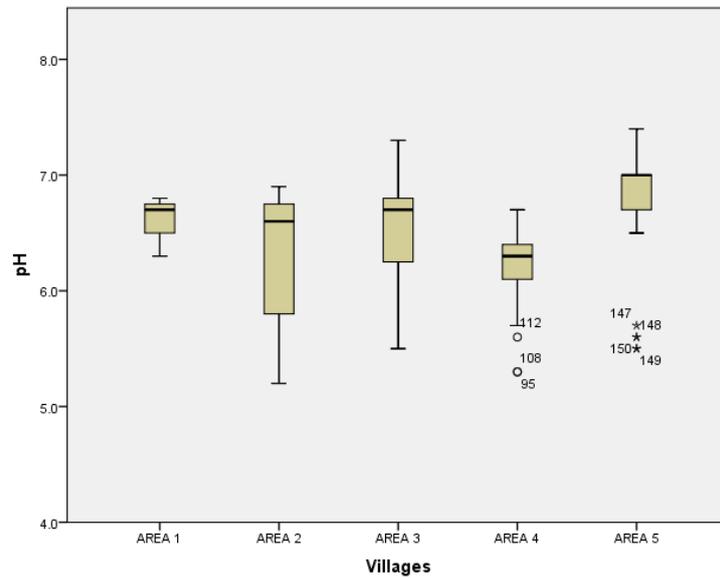
The median values of pH are between 6.5-7 for all areas. The pH values of samples from AREA 1 are highly uniform compared to AREA 2 and 3 which show high variance. AREA 5 shows to have higher median of about 7 compared to other areas. See Figure 15.

Figure 15 box plots of pH at medium scale

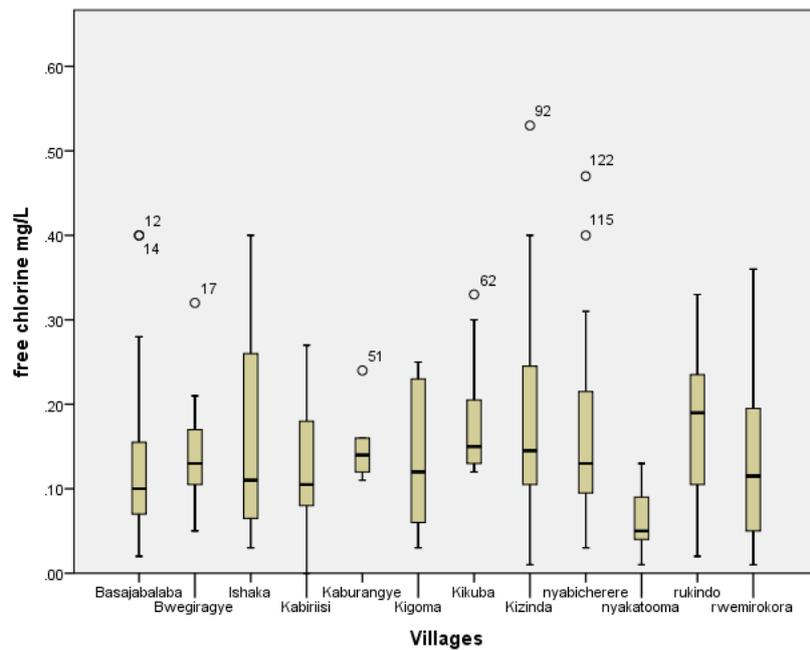
The maximum and the minimum allowable free chlorine in drinking water by the WHO is 5 mg/L and 0.2 mg/L, respectively. As seen in Figure 16, the residual chlorine for all samples ranges between 0-0.7 mg/L. Out of 169 samples, 128 (76%) samples had residual chlorine below 0.2 mg/L at the consumer outlets while 41 (24%) samples had chlorine residual above 0.2 mg/L.

Figure 16 box plots of free chlorine levels at the village scale

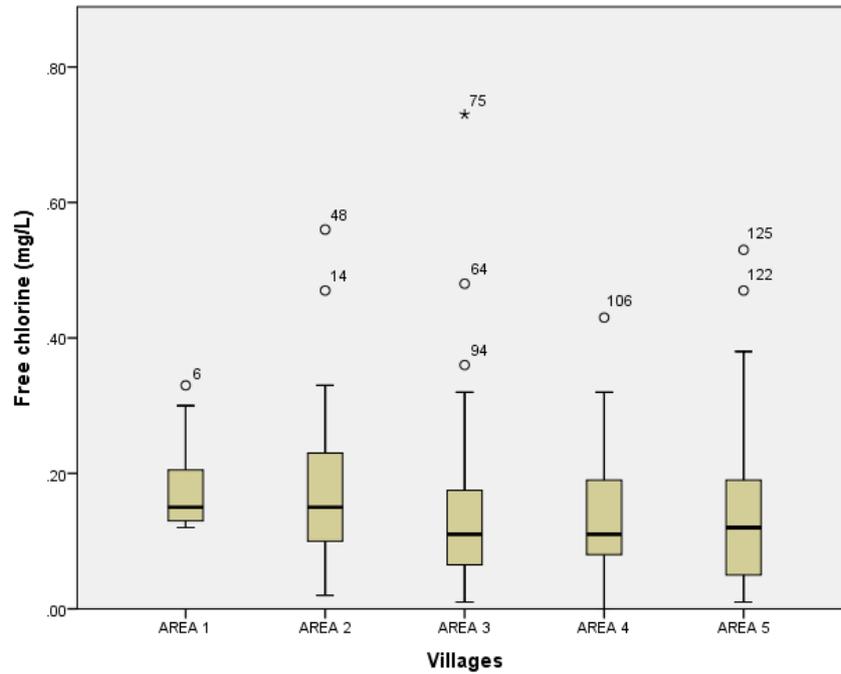
According to Figure 17 the median free chlorine values for all areas are < 0.2 mg/L. Most values are < 0.4 mg/L except for the outliers that up to 0.7 mg/L.

Figure 17 box plots of free chlorine levels at medium scale

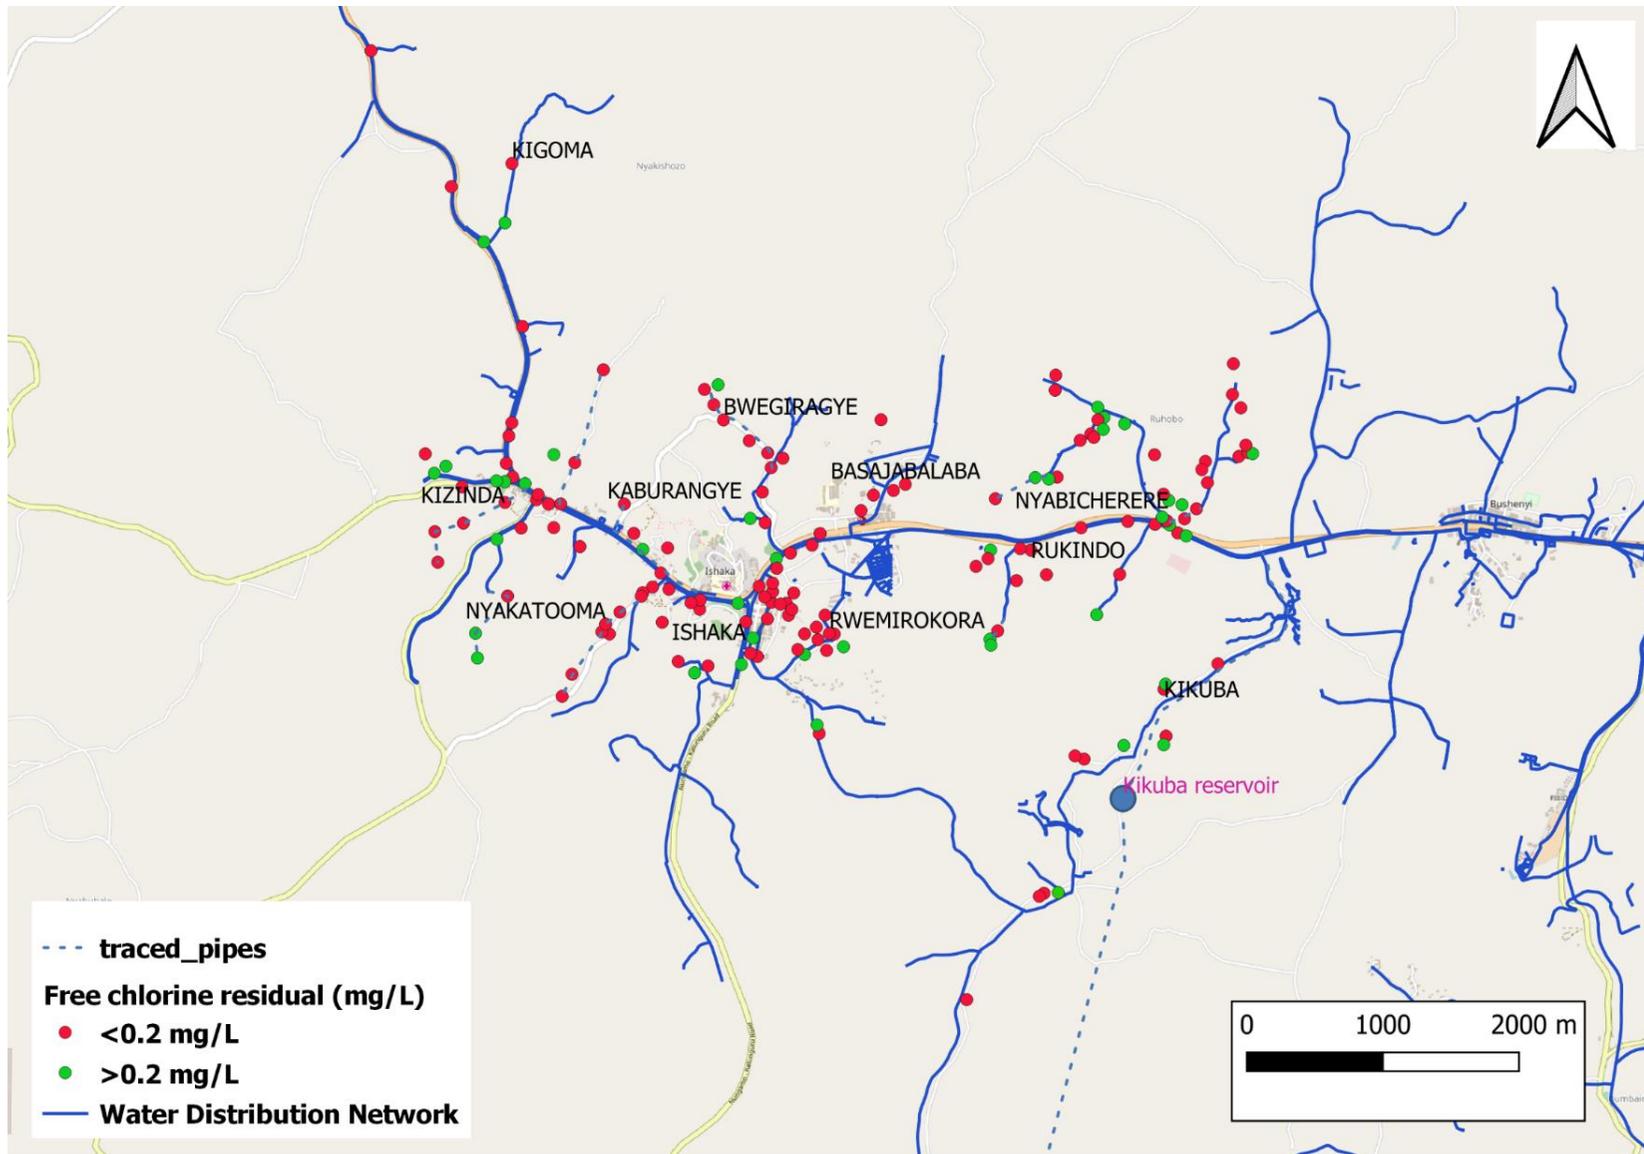
The map shows that most of the samples have a chlorine residual below 0.2 mg/L. All the villages have samples with chlorine residual < 0.2 mg/L. Nyakatooma and Bassajabalaba show to have the highest number of samples with a chlorine residual < 0.2 mg/L. It is important to note that these samples were collected on different days and time.

Figure 18 free chlorine residual per sampling point

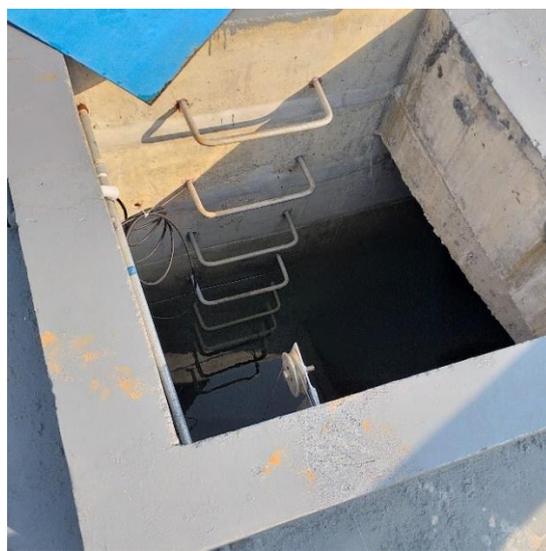
Figure 20 open inspection cover for the reservoir

As shown in Table 5.1-9, there were seven questions targeting risk factors at the reservoir. Generally, the reservoir was in good condition during the sanitary inspection. Four factors had no obvious hazards or hazardous events and thus no risk score, two were classified as low risk level, and one was considered to have a high probability of risk. The reservoir cover was in

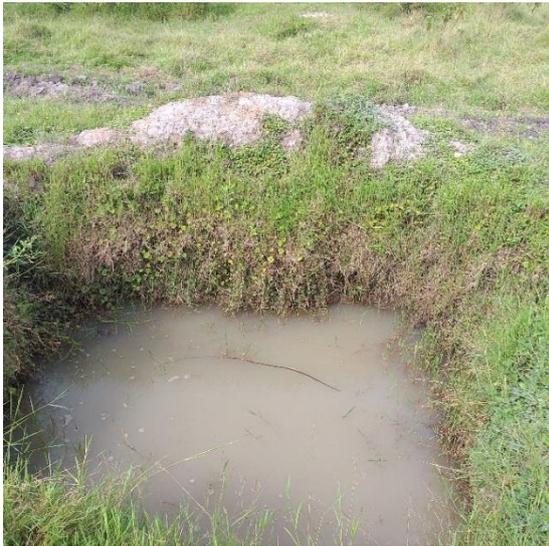
Solid waste dumping was observed and noted where there was exposed pipes. For example, there was visible solid waste dumping on this swamp and flow of wastewater from a nearby car wash where the pipe was exposed and submerged into the swamp.

Figure 21 ponding water in the swamp, joint left uncovered after repair

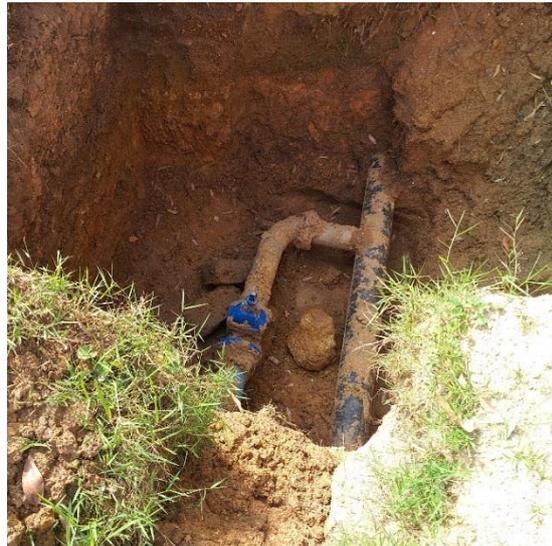
Figure 22 T-junction left uncovered after repair

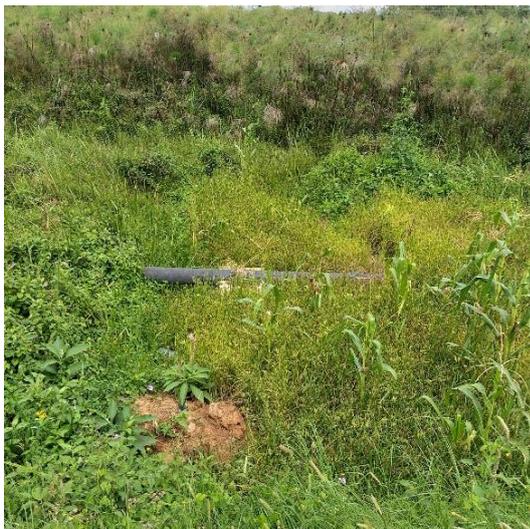
Figure 23 transmission main submerged in the swamp

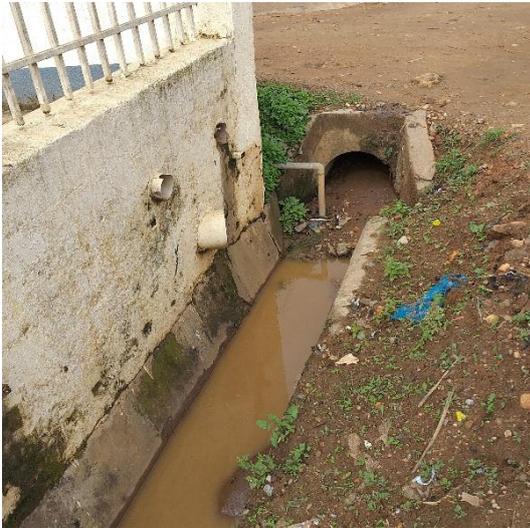
Figure 24 a pipe soaked in stagnant storm water

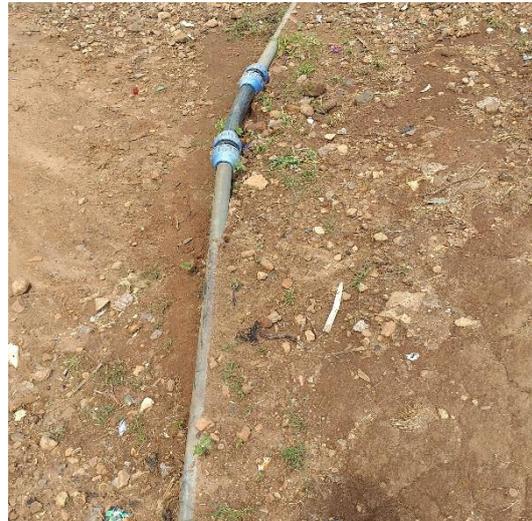
Figure 25 jointed pipes exposed due to erosion

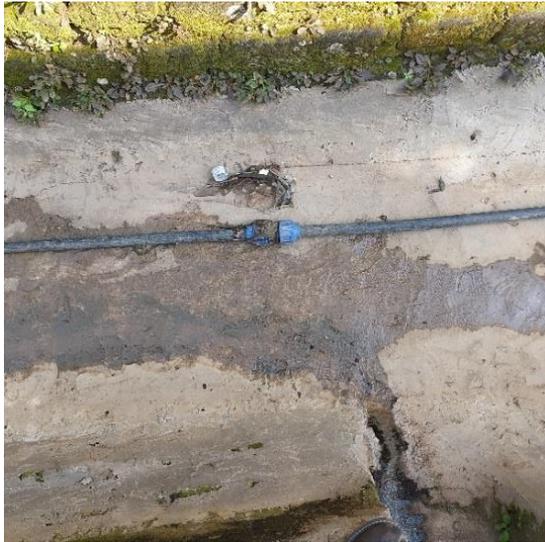
Figure 26 jointed pipes exposed and passing through the stormwater drainage

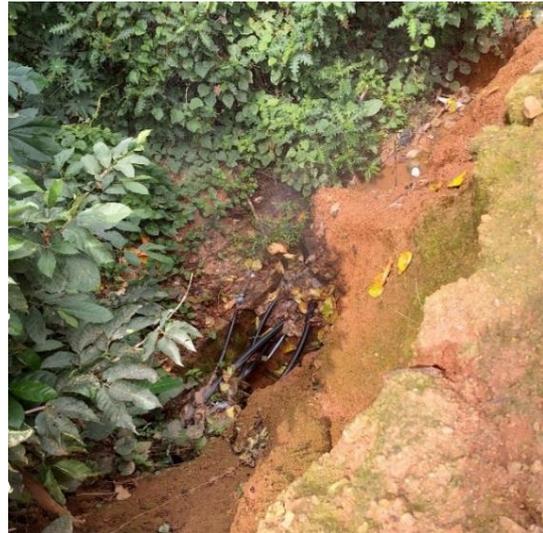
Figure 28 leaking pipes in a hidden place

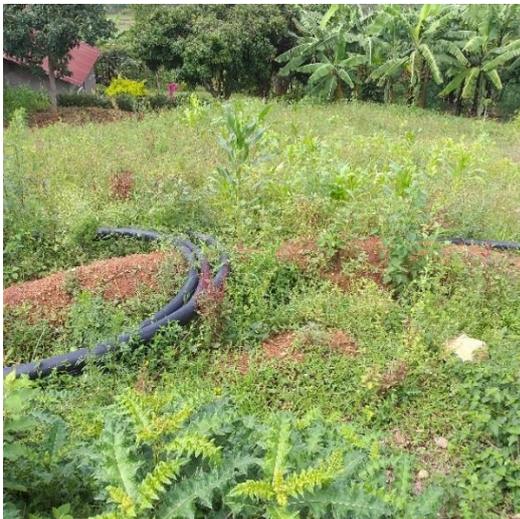
Figure 27 unused pipe left on site

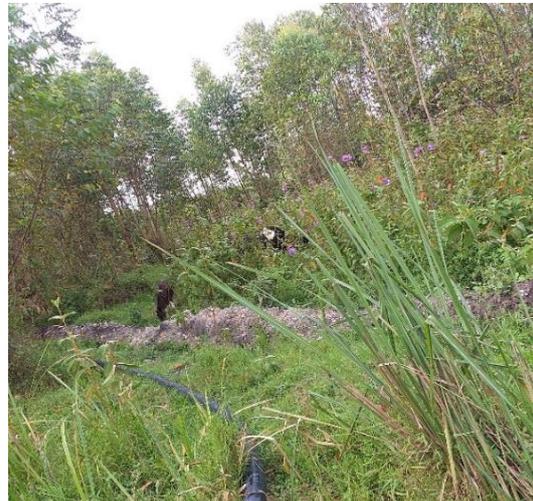
Figure 29 unused pipes left on site and animals grazing close by

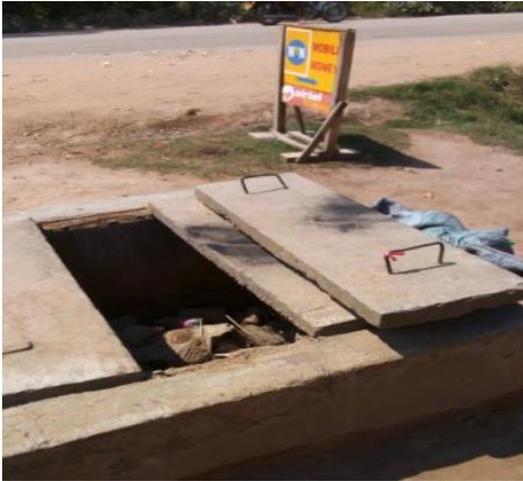
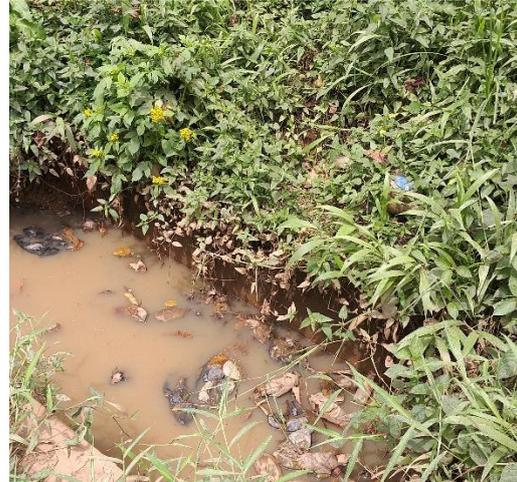
hospital and the stormwater in the hospital compound flows into the open valve chamber and there is also solid waste strewn in it and around it. See figure below

Figure 30 unsanitary valve chambers in Ishaka and Bassajabalaba

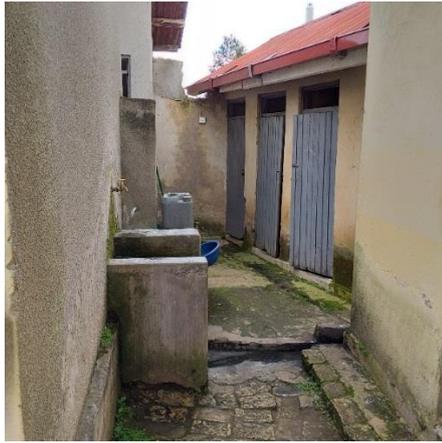
Apart from the risk factors provided by the sanitary inspection checklist, other risks were observed around the tap stands. Some other taps were located very close to a septic tank while others were located close to greywater trenches. Among the households, it was noted that most of the families owned a utensil rack and placed it close to the tap stand. The hazardous events are shown in Figure 31. According to many tap owners, there are barely any maintenance activities carried out towards the tap stands; a few people slash grass around the tap stand, others clean the concrete floor if present while others sweep around the tap stand. During sampling, one tap was found to be leaking while three meters were also found leaking.

a) a tap stand within 10 m proximity of the latrine

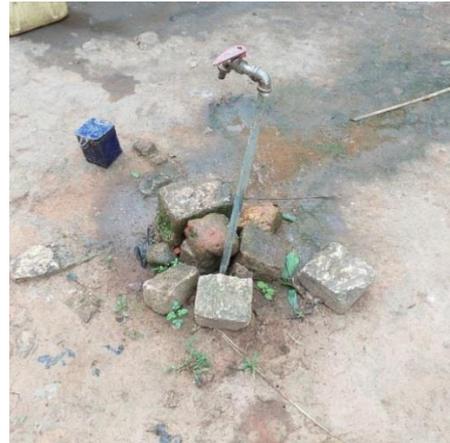
b) a tap stand with blocks at the floor

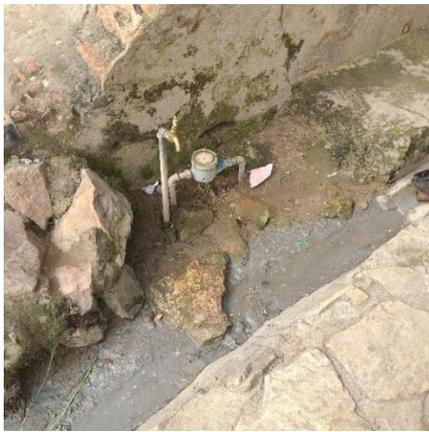
c) a tap stand built close to the grey water trench.

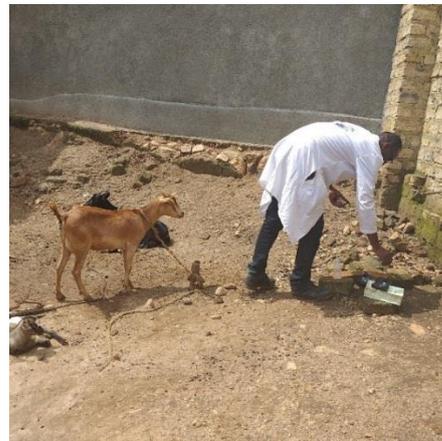
d) a tap stand with animals within 10 m proximity

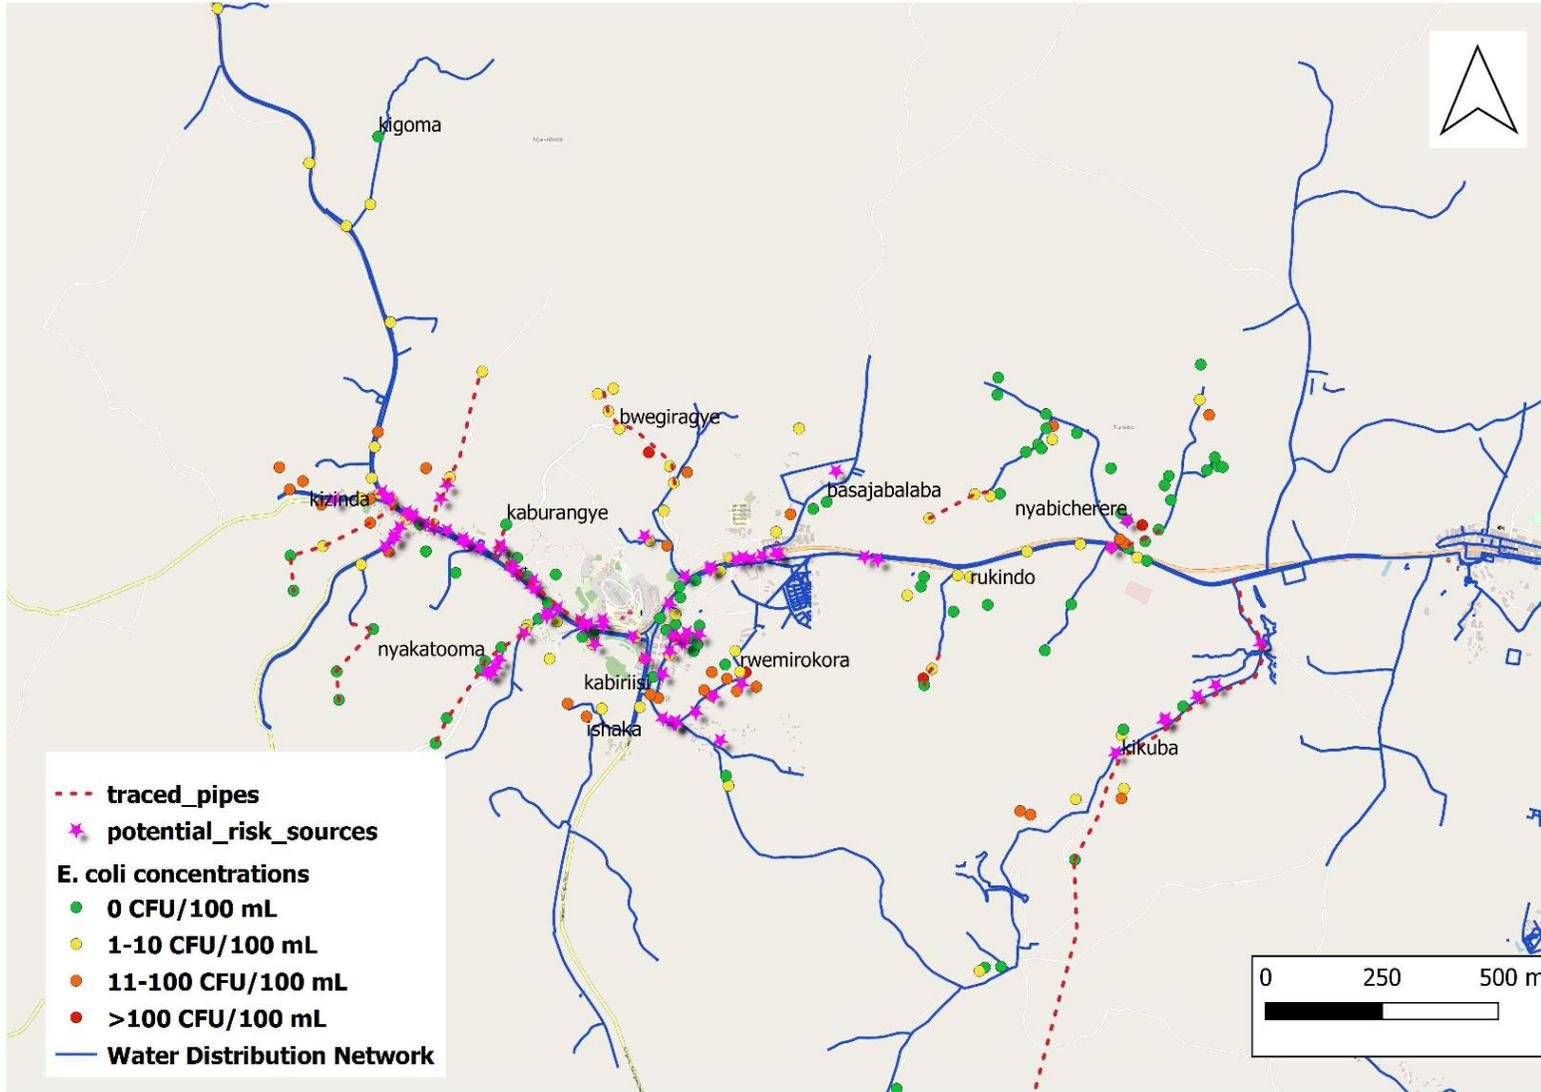
According to the map below, the risks observed along the distribution network does not have much association with the *E. coli* concentration. Generally, there are more hazards and hazardous events identified in shopping centres compared to more rural settings. In Kaburangye there were many risks observed; exposed pipes, poor drainage at the tap stand and signs of erosion but there was no observed *E. coli* concentration. On the contrary In Bwegiragye, there were very few risks observed but all the samples had *E. coli* concentration.

Figure 32 a map showing identified risk points along the water distribution network

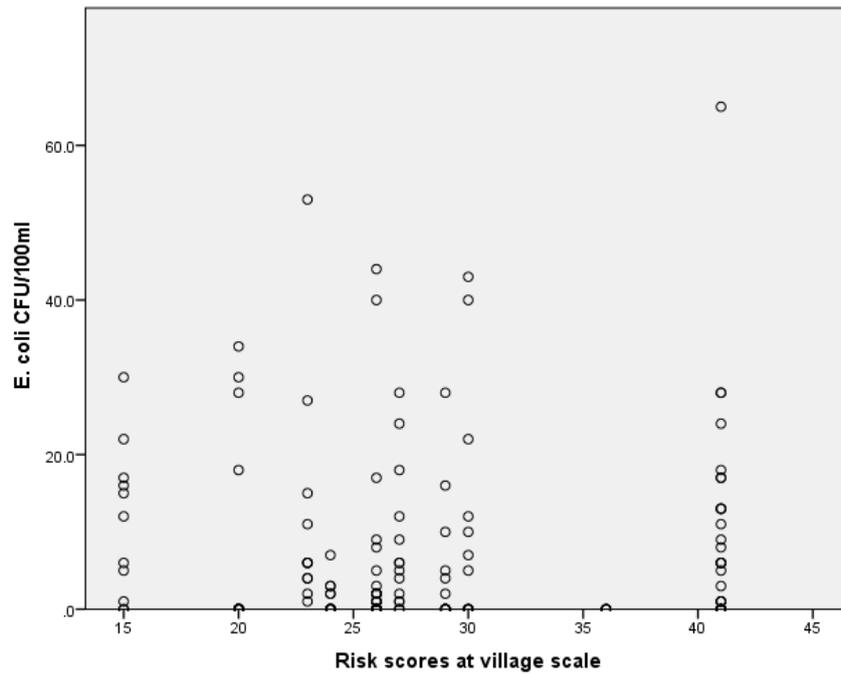
sanitary risk scores. Comparing the results of spearman's correlation and scatter plot, the positive correlation coefficient observed may be due to chance considering there is no significant relationship between the two.

Figure 33 a scatter plot showing the correlation between *E. coli* concentration and sanitary risk scores at the village scale

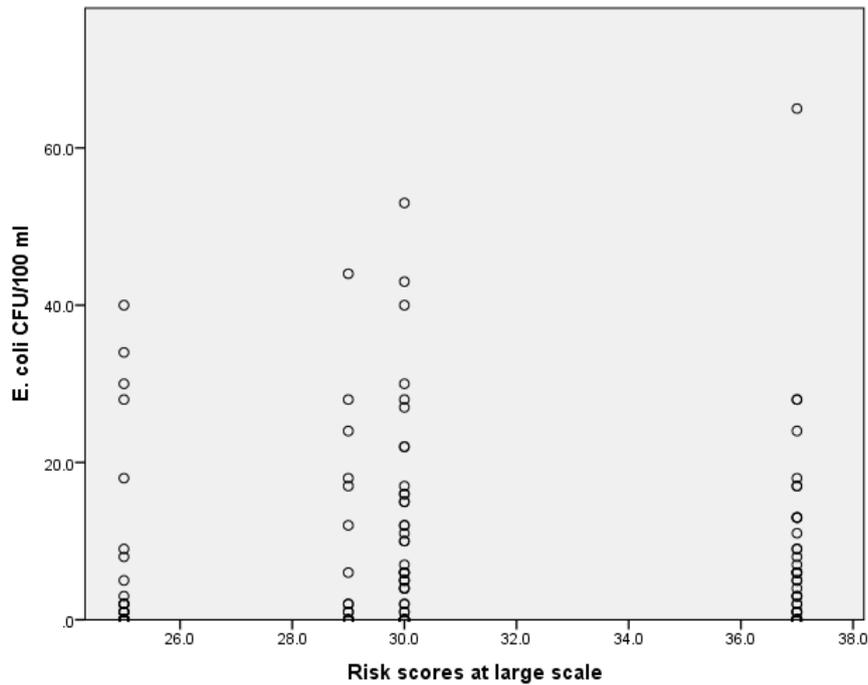
is 0.027 which are both very close to zero. These findings align with the positive coefficient observed in the Spearman’s ranking shown above. However, it is evident that the R-squared for correlation at village scale is greater than at medium scale.

Figure 34 a scatter plot showing the correlation between *E. coli* concentration and sanitary risk scores at large scale

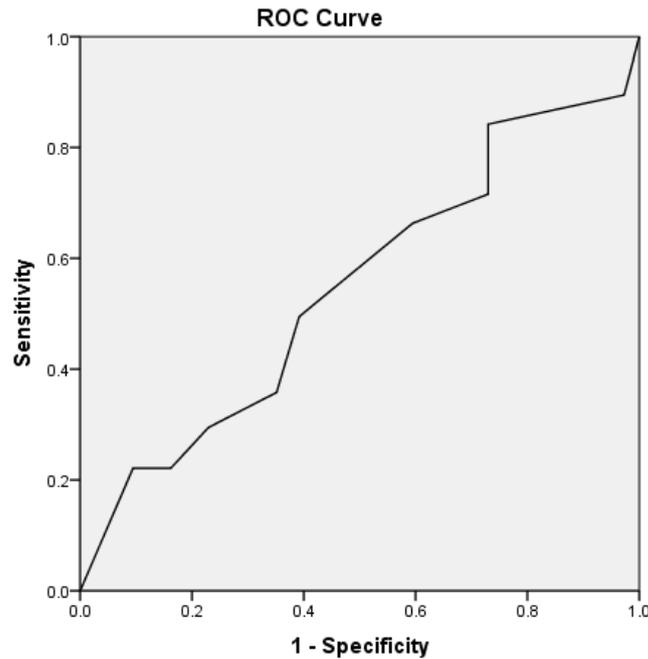
The null hypothesis where the sanitary risk score is not in play, estimates a 56% of samples with *E. coli* presence. However the sanitary risk score predicts that 51.5% of the samples are correctly predicted. A Receiver operating characteristic (ROC) curve was plotted (true positive rate against false positive rate) to check the accuracy of sanitary risk scores at predicting microbiological contamination. The accuracy of prediction is measured by the area under the ROC curve (AUC). The higher the AUC the higher the ability of sanitary inspections to predict positives as positives and negatives as negatives. According to Figure 35 the AUC is 0.547 which indicates that there is 54.7% chance that the *E. coli* concentrations are accurately predicted by sanitary inspections.

Figure 35 ROC curve showing predictive value at the village scale

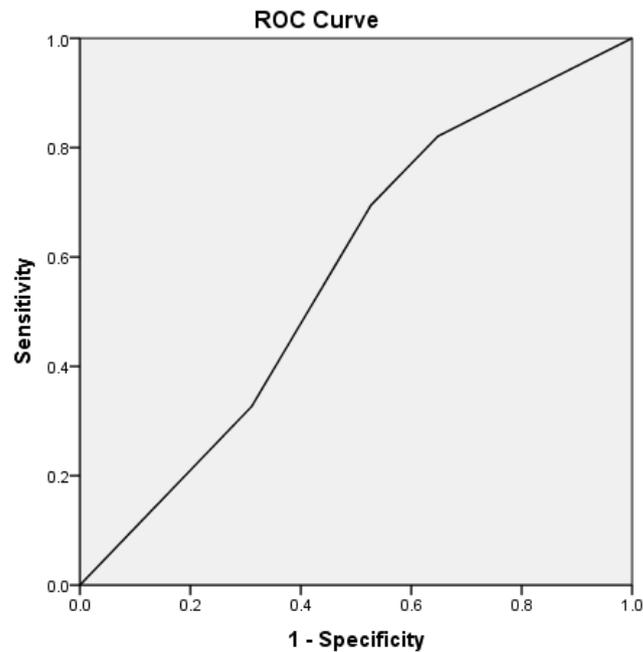
The null hypothesis where the sanitary risk score is not in play, estimates a 56% of samples with *E. coli* presence, however the sanitary risk score predicts that 51.5% of the samples are positive. A (ROC) curve was plotted to check the accuracy of sanitary risk scores at predicting microbiological contamination. According to Figure 35 the AUC is 0.573 which indicates that there is a 57.3% chance that sanitary inspections can be able to distinguish between the positive indication of faecal contamination and negative faecal contamination.

Figure 36 ROC curve showing predictive value at large scale

From the above analysis, it is evident that the sanitary inspections for piped distribution have poor ability to predict presence or absence of *E. coli* concentrations in the water.
